EWN Case Study: Mangroves

The Role of Shoreline Type in Mitigating Damage due to Hurricane Irma in the Florida Keys

RAE 2018 Short Course: Engineering with Nature (EWN) for Sustainable Estuaries

13 December 2018

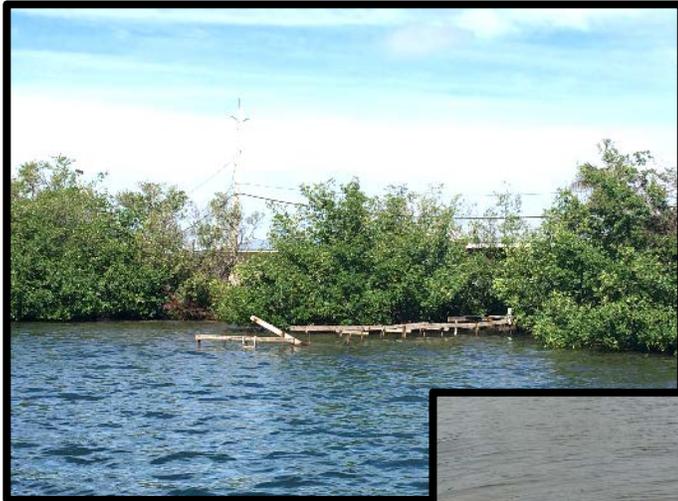
Mangrove: broken branches, loss of foliage, regrowth

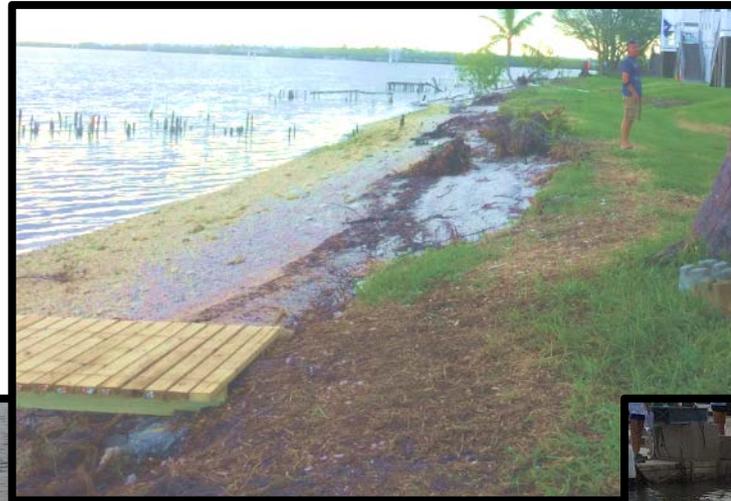
Sandy Beaches: erosion

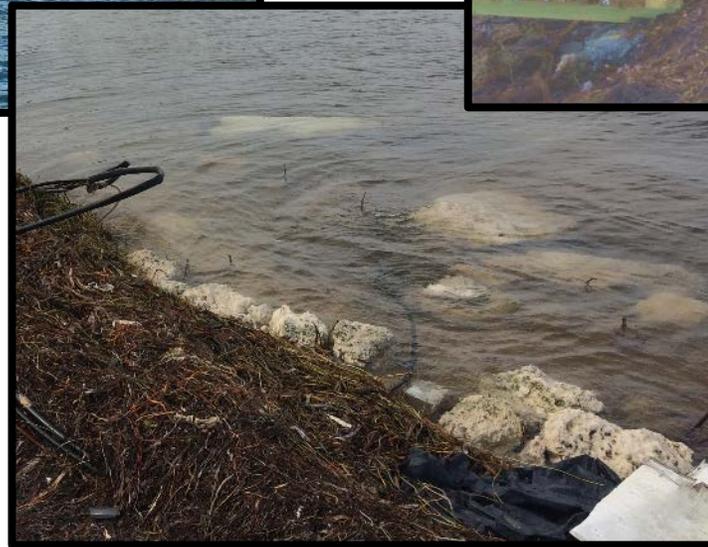
Revetment: rocks displaced

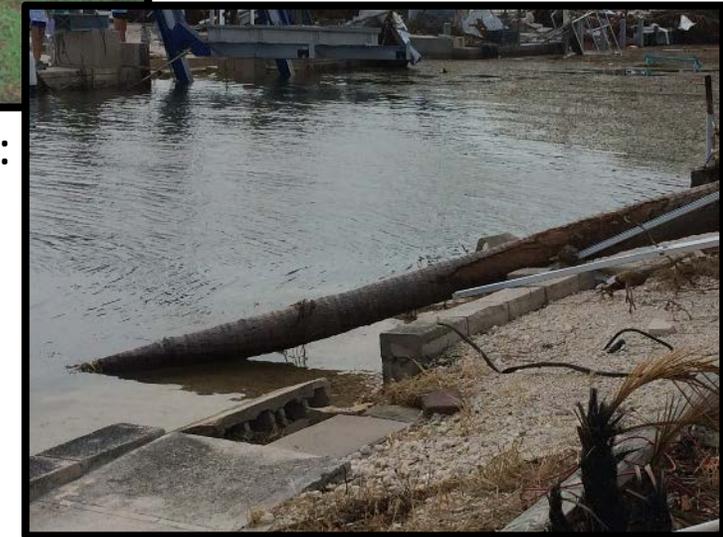
Bulkhead: cracks, undercutting, structural collapse
