# USACE Green Breakwaters Demonstrate Engineering With Nature through Pilot Projects

# Great Lakes Green Breakwaters Study

# Cleveland East Arrowhead Breakwater Project

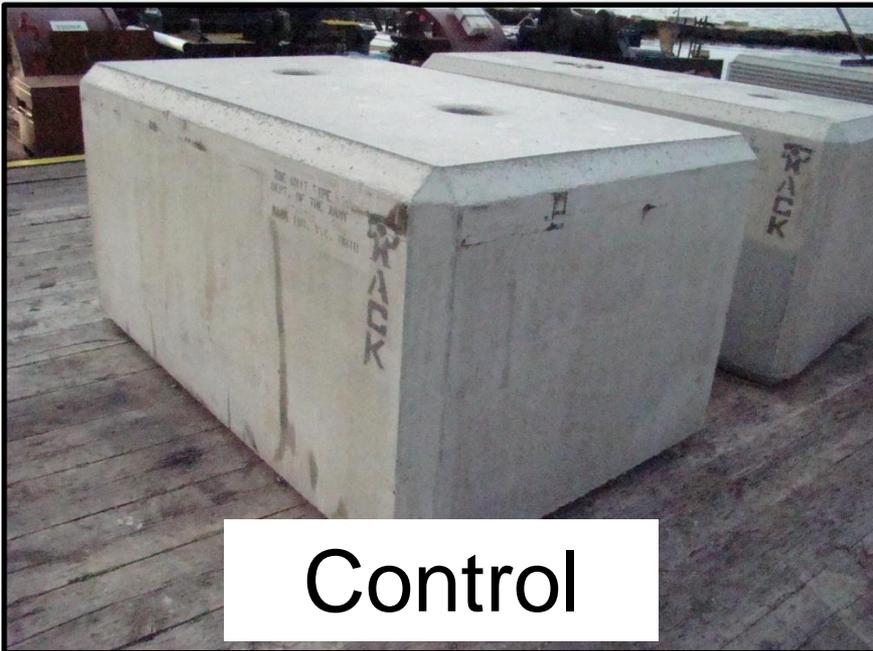
Control

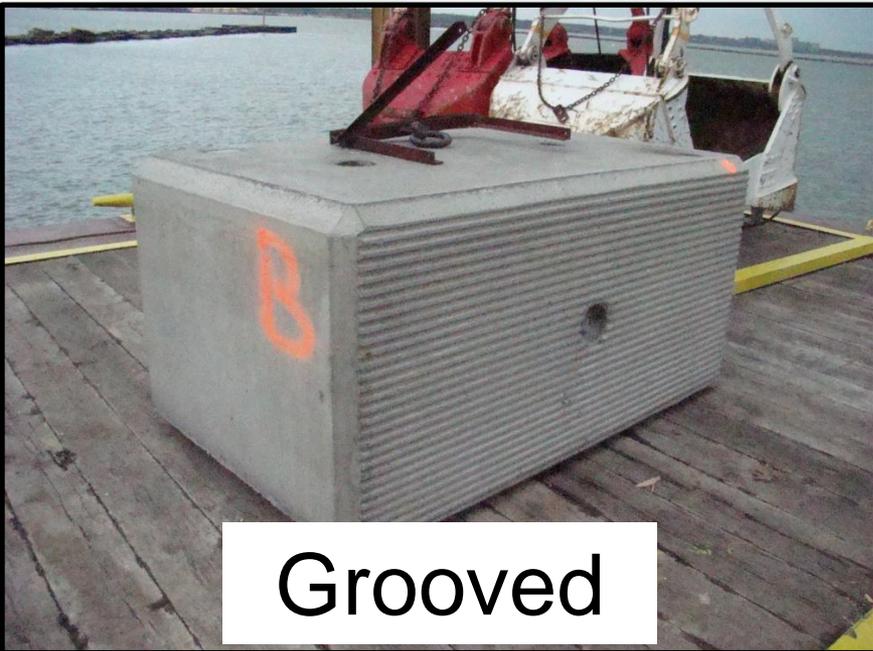
Grooved

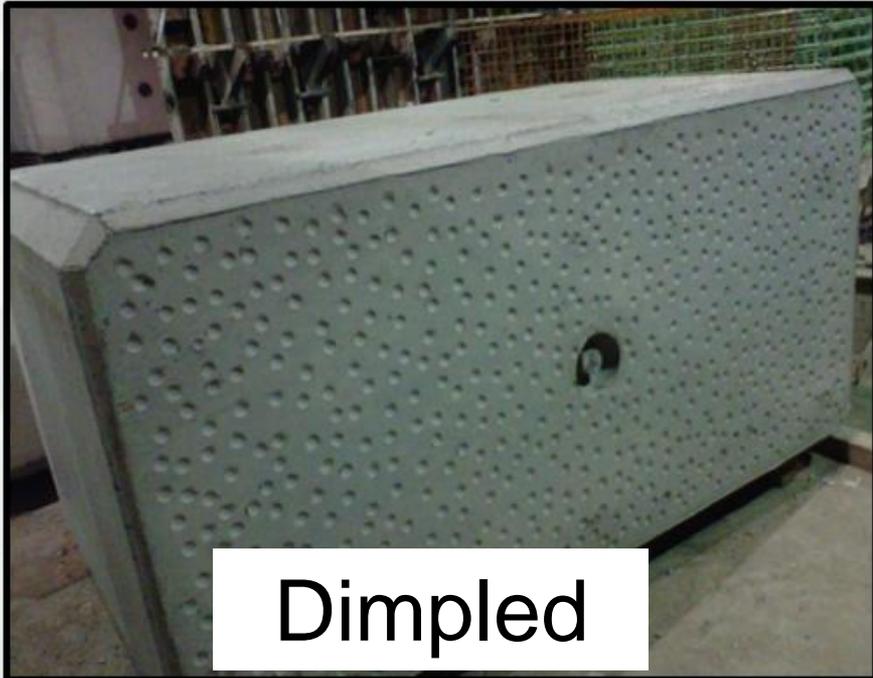
Dimpled

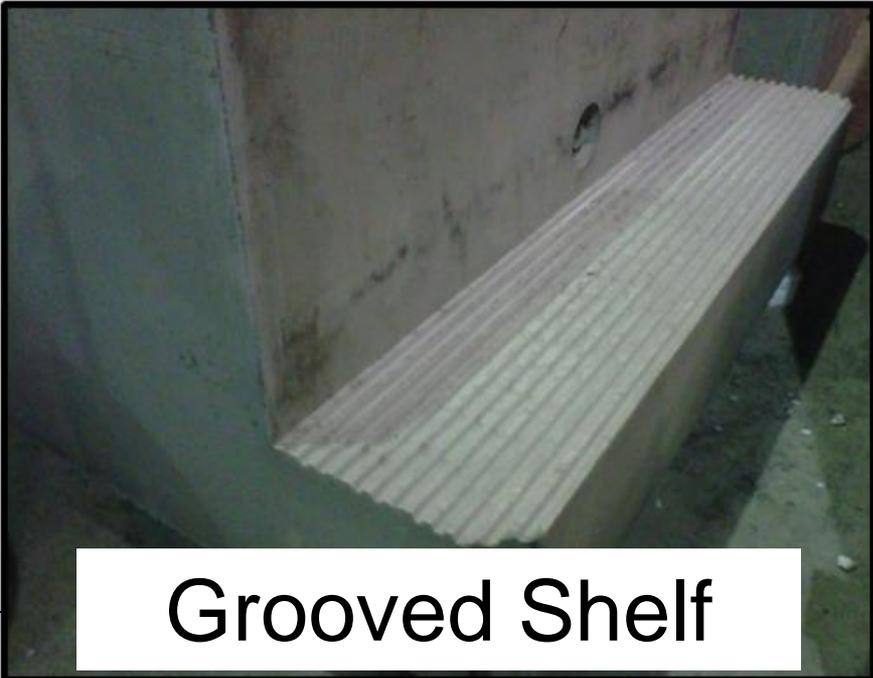
Grooved Shelf

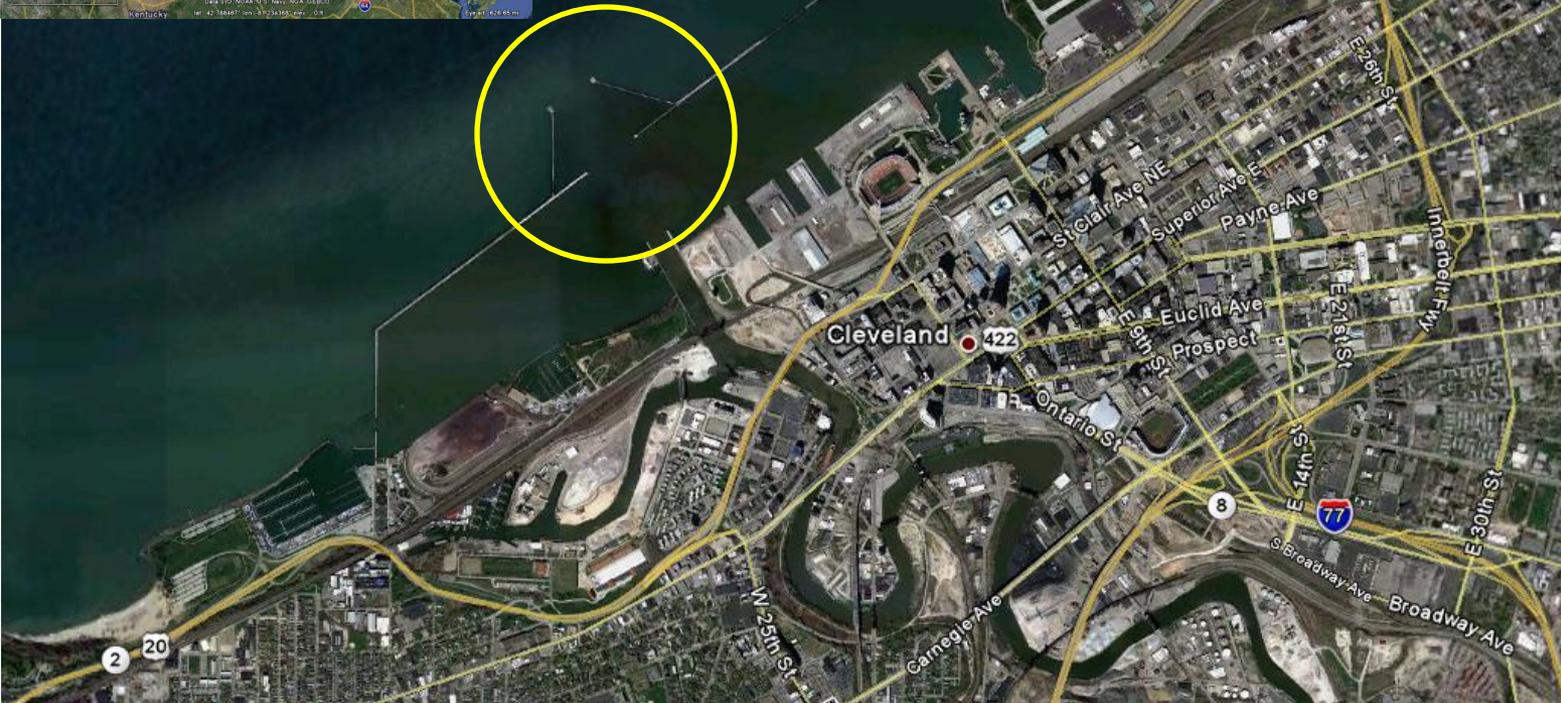
Cleveland  
East  
Arrowhead  
Breakwater –  
Lake Erie

Study Site

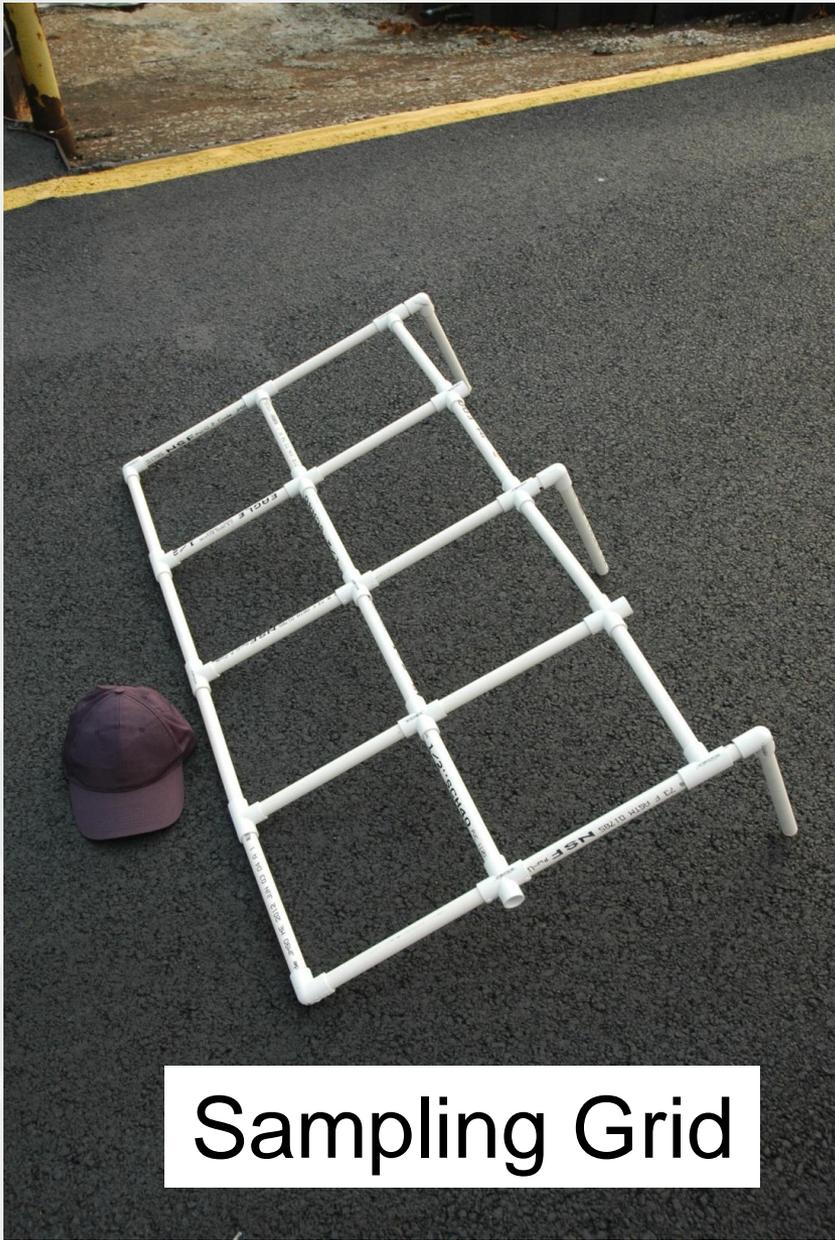
Sampling Grid

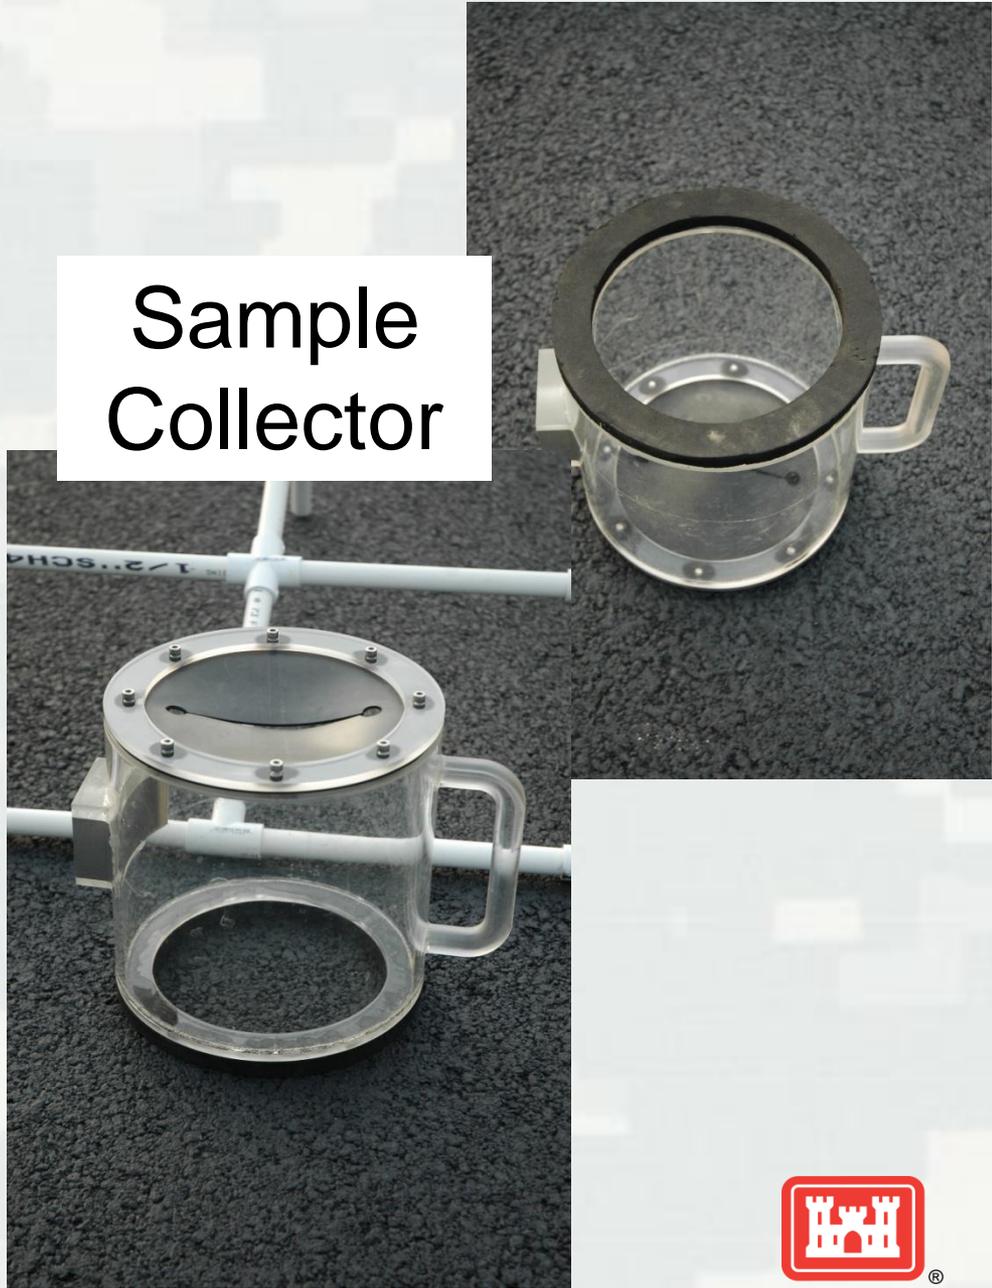
Sample Collector

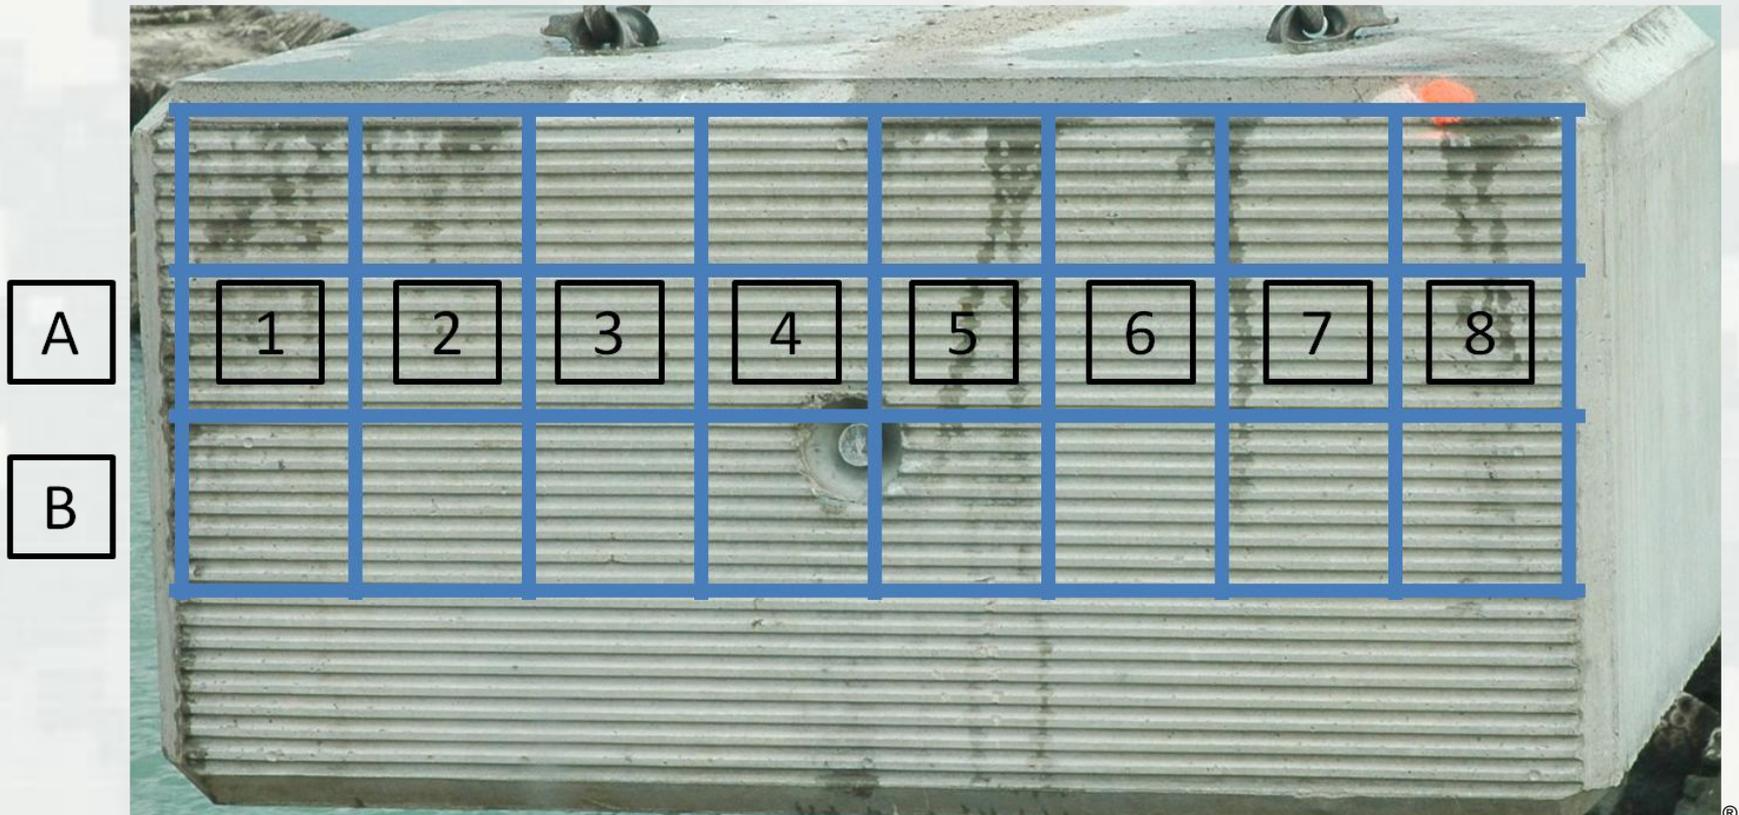
# Sampling Grid

- Top row was not submerged

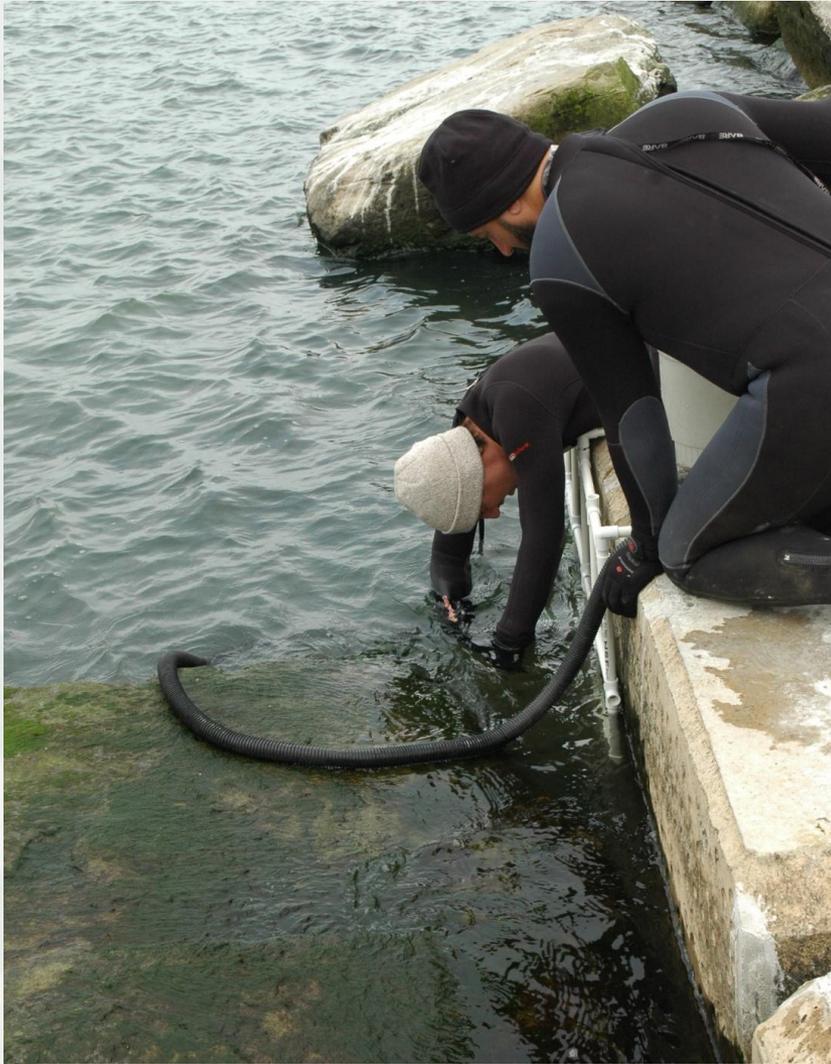
Sample Collection

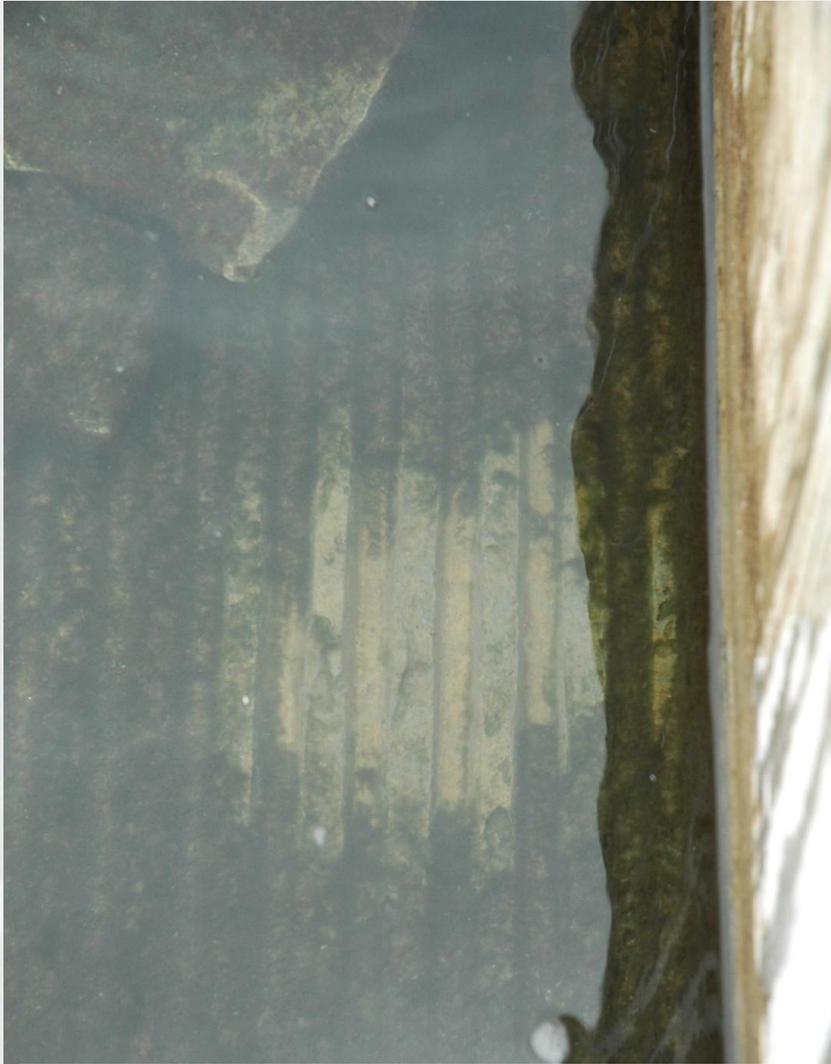
Post-sampled Area
