Special Series

Using Engineering With Nature[®] (EWN[®]) principles to manage erosion of watersheds damaged by large-scale wildfires

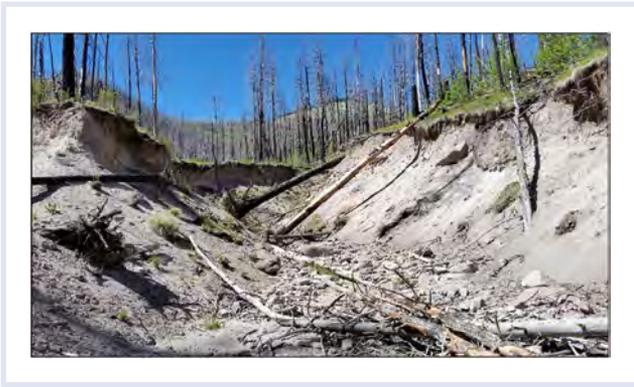
FIGURE 2 Incised tributary to Santa Clara Canyon showing a markedly expanded channel width post-wildfire

For context on what types of practices are applicable to treating massive erosion in watersheds, the physical processes that cause the accelerated rates must be identified and understood. Network-wide channel instability was identified by localized steepening of slopes, mass wasting of streambanks, and widespread channel expansion, in some cases 5–10 times the pre-fire widths (Figure 2). Many of these tributary channels were shallow, easily crossable

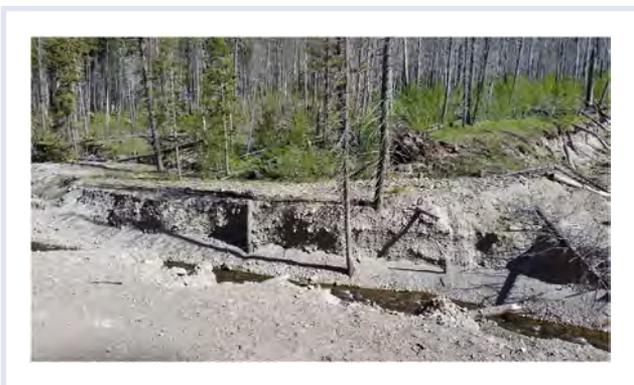
FIGURE 3 Santa Clara Creek illustrating large deposits of post-wildfire sediment deposition from watershed runoff events

The tributary watersheds experienced large-scale channel degradation and deposited massive amounts of debris and sediment to the main channel and floodplain of Santa Clara Creek (Figure 3). Channel evolution models (CEM; Cluer & Thorne, 2013; Hawley et al., 2011; Schumm et al., 1984; Simon & Hupp, 1986) can be used to predict spatial and temporal extents of channel stability within watersheds. Based on a simplistic approach, the qualitative five-stage CEM (Schumm et al., 1984) was selected to assess the tributary and mainstem geomorphology. The CEM was used to identify primary post-wildfire stream morphologic processes and potential future channel stability trends.
